George J. Hartman Architects, P.C.

July 23, 2021

Re: Building Evaluation Report
Lake Angelus Police Station
3575 Baldwin Road

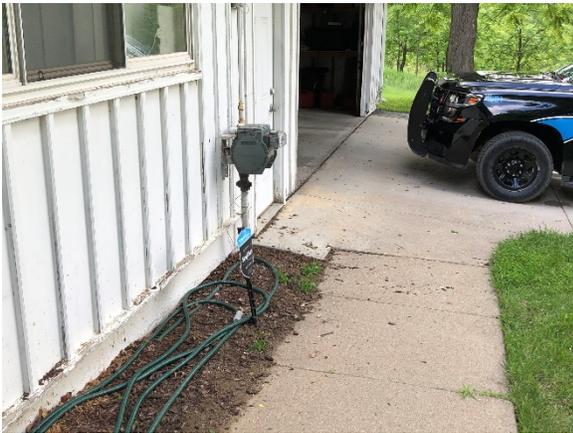
IMAGE 4

- The sidewalk at the front entrance to the building is 4” below the floor of the building. This is required to be level with the building floor. **(IMAGE 4)**

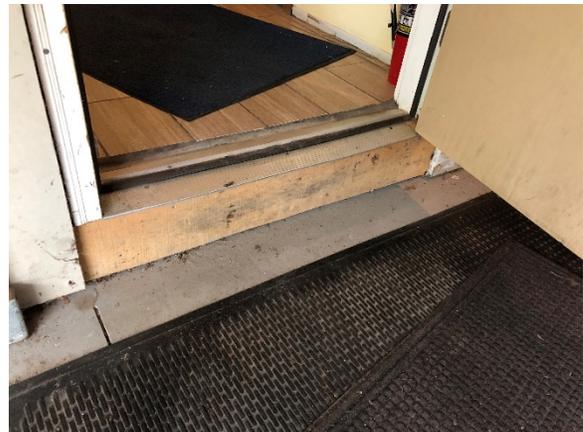
IMAGE 2

- The sidewalk from the driveway to the front building entrance has a running slope of 5.2% average and at several locations a side to side slope of 10%. The running slope classifies this walkway as a ramp and requires handrails. The side to side slope exceeds the allowable side to side slope of 2%. **(IMAGE 2,3)**

- A detectable warning strip should be placed at the intersection of the sidewalk and driveway to comply with the accessibility code. **(IMAGE 2)**
- There is no marked vehicle parking for visitors or barrier free parking.

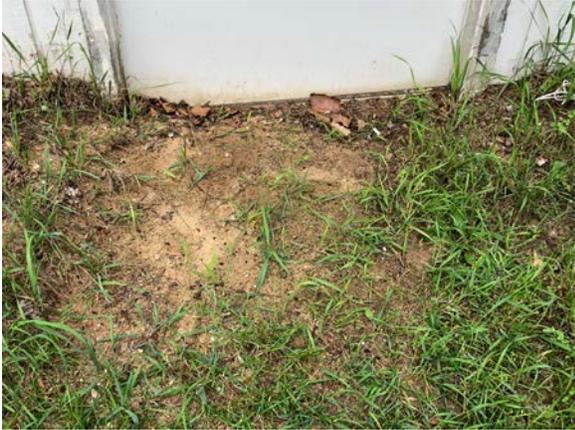
IMAGE 6

- The grade at all exterior main level doors is approximately 6” below the floor and does not comply with building code egress requirements. There is no concrete landing at the rear egress door from the stairwell. **(IMAGE 5,6)**

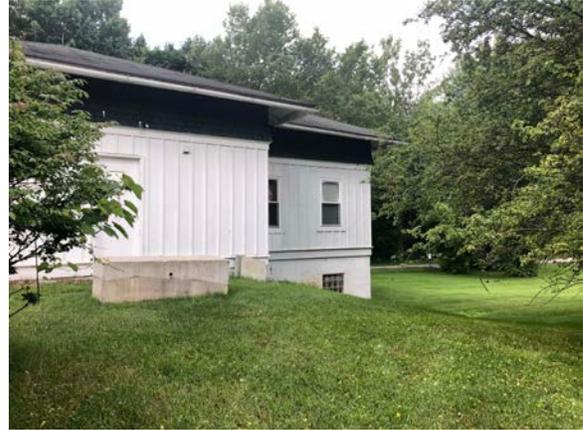
IMAGE 7

- The grade at the basement egress door is above the threshold of the door. There is no concrete landing at this location. **(IMAGE 7)**
- Erosion of the sloping earth on the south side of the building is held back by a plywood bulkhead. **(IMAGE 8,9)**

- The wood framing at the basement egress door shows rotting at the grade level. **(IMAGE 7)**
- Many areas of the board & batten drip edge are rotted, with rot apparent in the board & batten along the drip edge. **(IMAGE 17,18)**

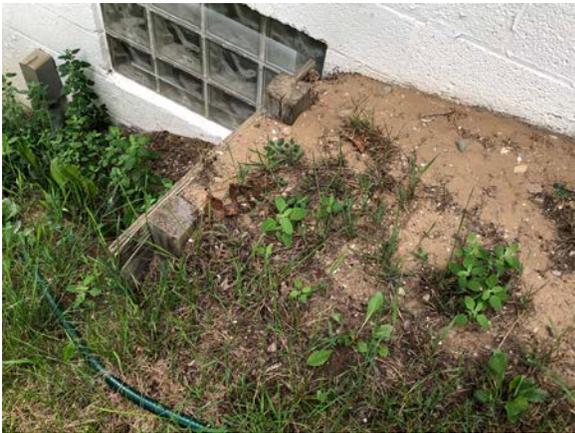
IMAGE 10

- Various forms of concrete barriers are placed around the building as protective measures to prevent vehicle intrusion. **(IMAGE 10,11)**

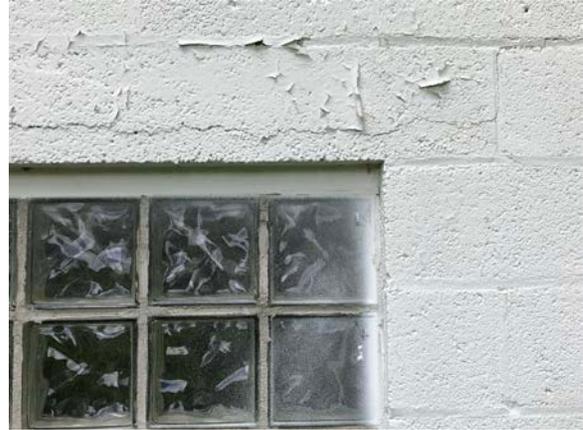
IMAGE 13

- The exterior paint is generally failing in most areas of the exterior. Many areas lack paint completely. There is bare wood exposed in many areas. **(IMAGE 12,13)**

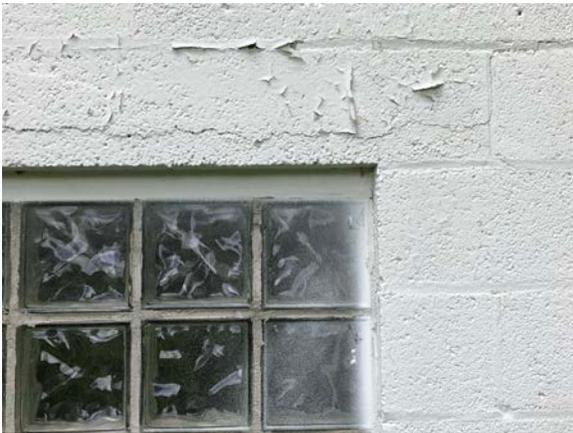
IMAGE 16

- The basement concrete block window headers show horizontal cracking, most likely from rusted reinforcing expansion. **(IMAGE 14,15)**
- There is some vertical and horizontal cracking visible in the basement concrete block. **(IMAGE 16)**

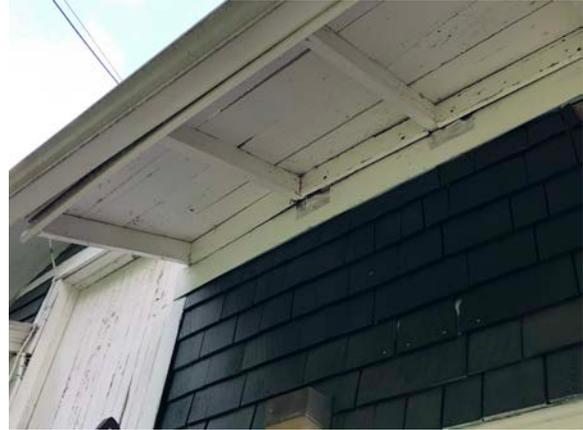
IMAGE 19

- Wood window sub-sills are beginning to rot. **(IMAGE 19)**
- Many areas of the exterior board & batten, wood shingle siding and trim boards show signs of bird damage from pecking, most likely due to bug infestation in the wood. **(IMAGE 20,21)**

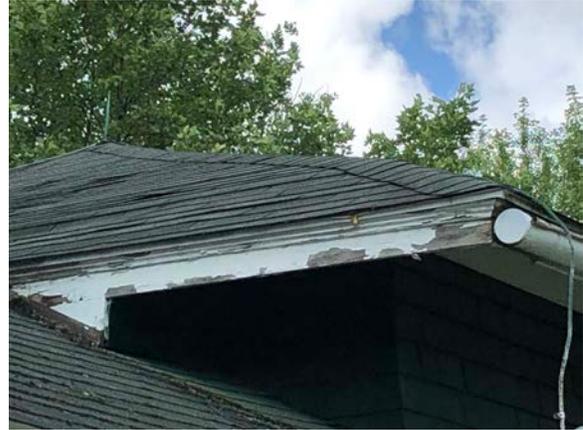
IMAGE 25

- The original gutters are still on portions of the building and failing with holes evident. **(IMAGE 24,25)**

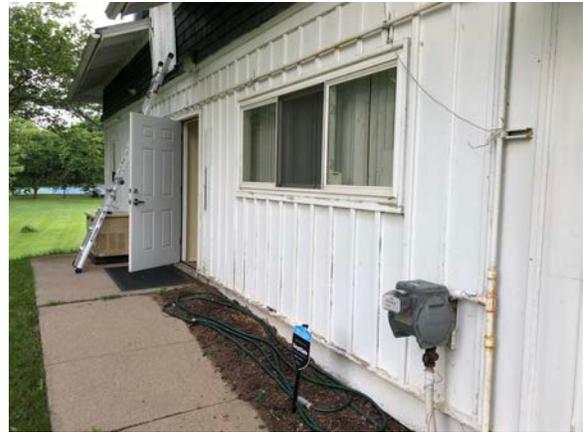
IMAGE 27

- The gutters over the front of the garage are plugged and overflow water to the drive creating a dangerous condition in cold weather. **(IMAGE 26)**
- Some downspouts at the garage spill to grade and flow water over the drive creating a dangerous condition in cold weather. **(IMAGE 27)**
- Asphalt roof shingles and roof boards are beginning to cup on the eastern side of the roof. **(IMAGE 28)**
- There are signs of animals digging along the foundation. **(IMAGE 29)**
- The exterior doors are a residential quality insulated metal door. These are not secure doors. The front entry door swings outward with hinges exposed to the exterior. **(IMAGE 30)**

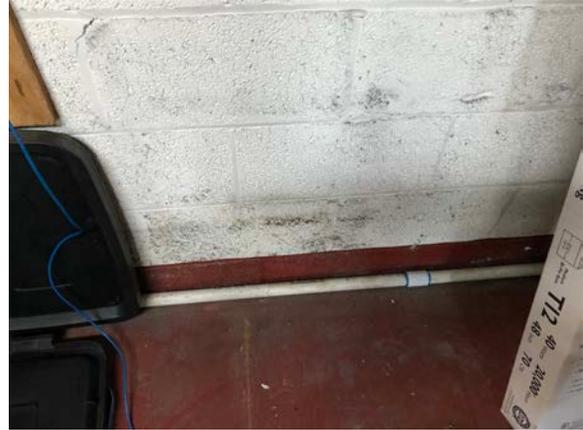
IMAGE 31

- The basement walls are constructed of concrete block. The block has the appearance of being a “light-weight” form of block, not a “standard-weight” block. **(IMAGE 31)**

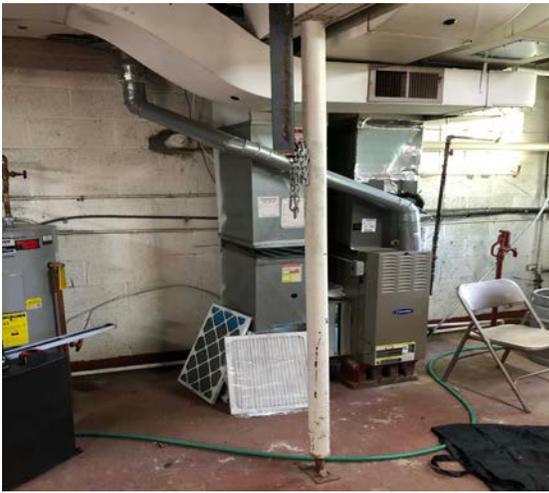
IMAGE 34

- The east and south walls show some mold staining on the lower parts of the walls, possibly from failure of waterproofing. **(IMAGE 33,34)**
- The existence of perimeter drain tile is unknown. There is no sump or drainage system visible.

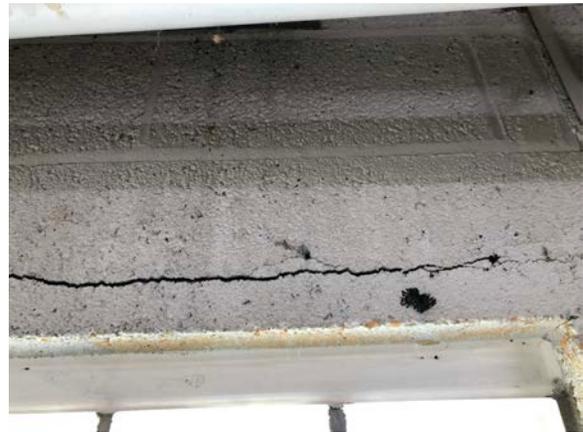
IMAGE 32

- The south wall of the basement has three quarters of an inch of bow in the middle of it as measured from the basement slab to the top of the wall. **(IMAGE 32)**

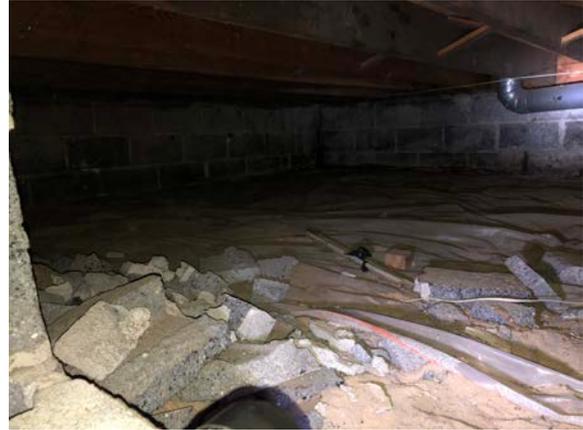
IMAGE 37

- Some cracking is visible in the vertical and horizontal mortar joints of the block walls indicating some movement of the block. **(IMAGE 37)**
- There is no evidence of any type of reinforcing in the block walls.

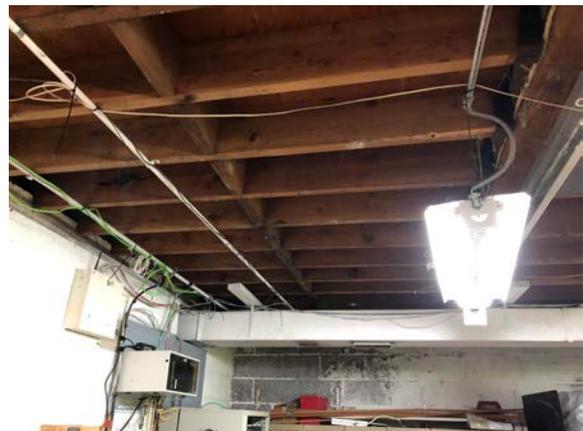
IMAGE 39

- There is no insulation visible in the basement. There is no insulation for the rim area of the floor framing at the basement. Some rim joist insulation appears visible in the crawl space. **(IMAGE 39)**

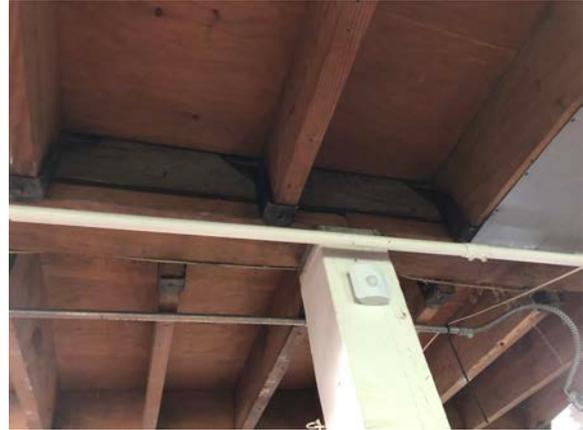
IMAGE 43

- Floor joists over the basement area are 2 x 8 size and run east to west. **(IMAGE 42)**
- The joists have a notch cut in the ends where they bear on the exterior walls. This effectively reduces the depth of the joist to a 2 x 6 size. **(IMAGE 43)**

- There is no physical connection of the joists to the top of the concrete block basement wall. **(IMAGE 43)**
- The joists are over-spanned in the westerly end of the basement allowing for excessive deflection.

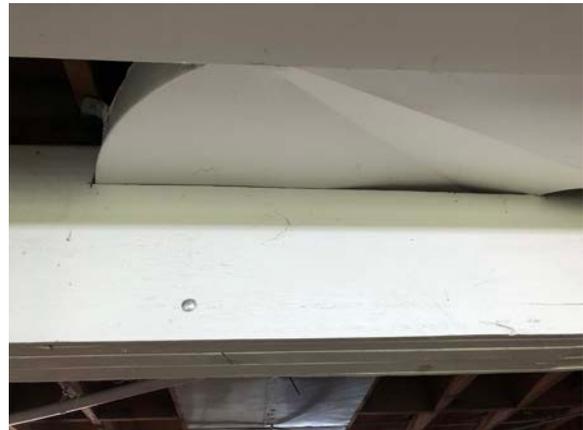
IMAGE 44

- A number of joists have been cut to accommodate plumbing lines, plumbing fixtures, ductwork, and electrical fixtures. **(IMAGE 44)**
- The subfloor and joists under the locker room shower show signs of water leakage and rot. **(IMAGE 45)**

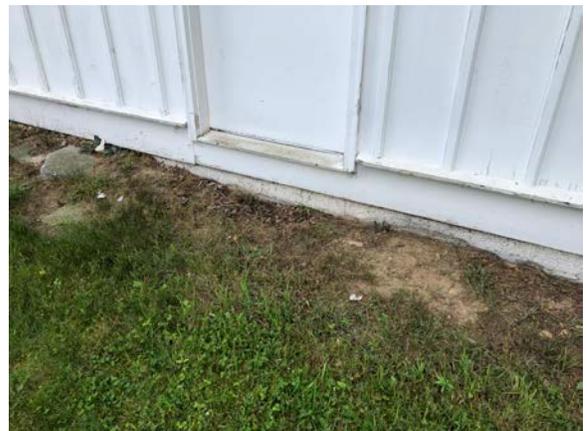
IMAGE 51

- The front entry door is an outswing door with hinges exposed to vandalism. **(IMAGE 51)**
- There is a 4" step up from the sidewalk to the vestibule. **(IMAGE 52)**
- There is a 7-1/2" step down to the garage. **(IMAGE 53)**
- The rear door on the north has a 12' step down to grade. **(IMAGE 54)**
- The tile floor is cracking throughout the main level. In many areas the tile is loose and creating a safety hazard. **(IMAGE 55)**
- The ceiling in the break room and shower are showing signs of failure with cracking and sagging. **(IMAGE 56,57)**
- The wall tile in the shower is showing signs of failure due to water and moisture issues. The tile is bowing off of the wall. **(IMAGE 58)**

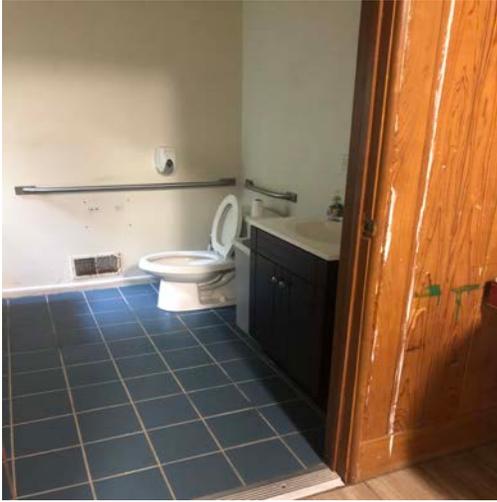
IMAGE 61

- The main level of the building generally does not comply at all with the “Accessible and Usable Buildings and Facilities” code which the State of Michigan utilizes. The main floor, (and site), do not have proper slopes, clearances, fixtures, accessories and access as required by the building code. **(IMAGE 61,62)**

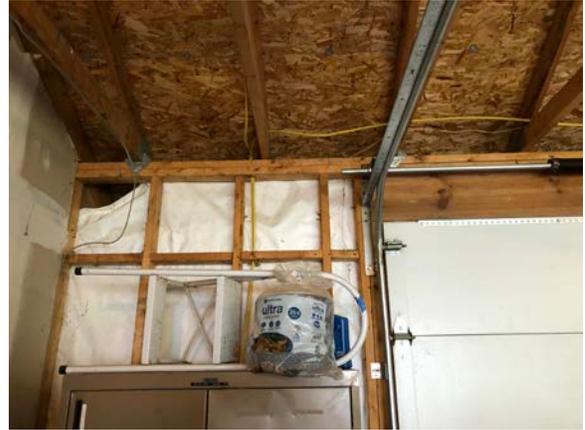
IMAGE 64

- The garage walls have a vapor barrier (Tyvek) applied directly to the exterior stud face with the exterior board and batten siding applied over the vapor barrier. There is no sub-sheathing installed. **(IMAGE 64)**

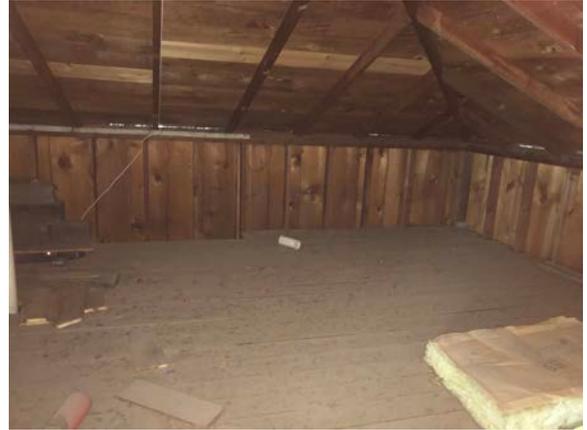
IMAGE 67

- There are many gaps in the exterior siding and framing where daylight is visible through the wall system. **(IMAGE 66,67)**
- The 2 x 4 exterior wall balloon framing is bowing outward at the top of the wall. The amount of outward bow varies from one or two inches to almost five inches at the worst condition. The outward bow is caused by the lateral force of the roof rafters. **(IMAGE 68)**

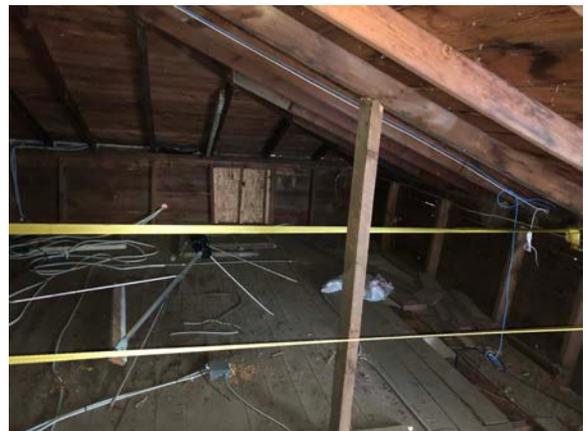
IMAGE 69

- The 2 x 4 rafters are severely over-spanned for the rafter spacing, rafter size and span. The rafters exhibit sagging due to the over-span condition. **(IMAGE 69)**

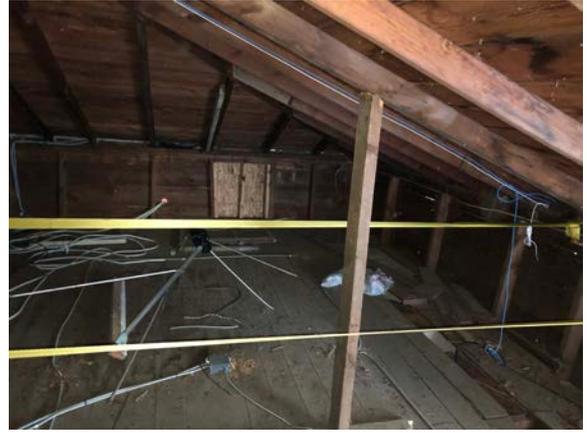
IMAGE 73

- The attic has no eave or roof ventilation. **(IMAGE 73,74)**
- The 3” to 6” of attic insulation visible is insufficient to meet current energy code standards.

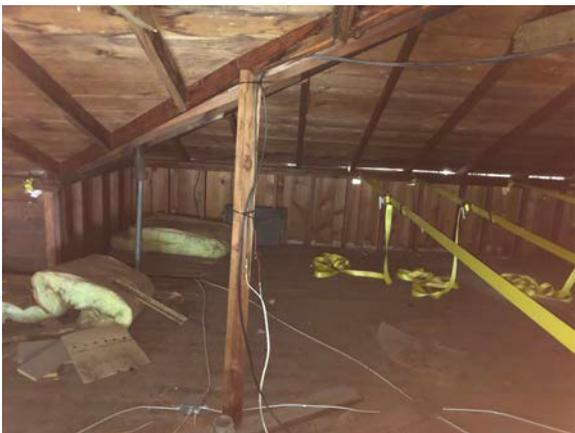
IMAGE 77

- A significant amount of exposed Romex wiring is run loosely across the attic floor and the ceiling of the basement and crawl space. This presents a hazard where the wiring could be accidentally pulled free of connections and cause a power disruption, injury or fire. **(IMAGE 75,76,77,78)**

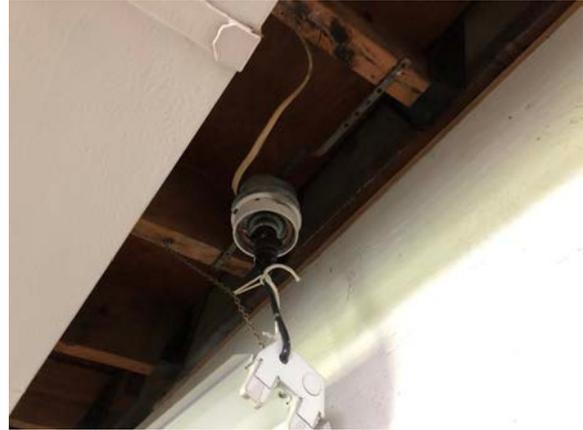
IMAGE 79

- Some of the flexible conduit (MC Cable) is also loosely run in the attic and basement areas. **(IMAGE 79,80)**
- The electrical fixtures located in the shower are not proper for the location and present an electrical hazard to persons using the shower. **(IMAGE 81)**

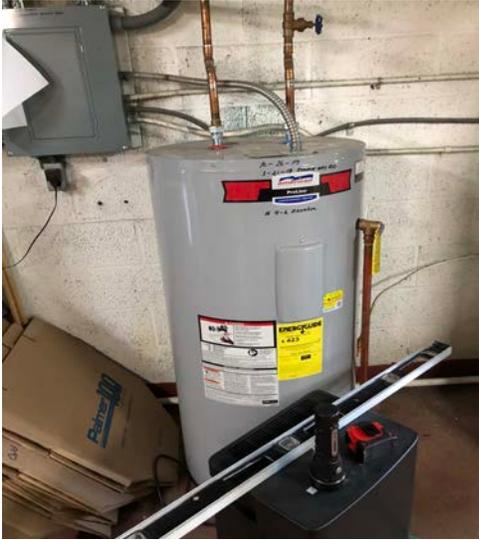
IMAGE 96

- The well tank is newer with an installation date of 2018. No issues are known. **(IMAGE 96)**
- The water heater is also newer with an installation date of 2017. No issues are known. **(IMAGE 97)**
- The drain piping for the shower shows signs of leakage, possibly from a failure of the shower membrane. **(IMAGE 98)**
- Plumbing fixtures and installations do not comply with the accessibility code. **(IMAGE 99,100)**
