George J. Hartman Architects, P.C.

July 23, 2021

Re: Building Evaluation Report
Lake Angelus Police Station
3575 Baldwin Road

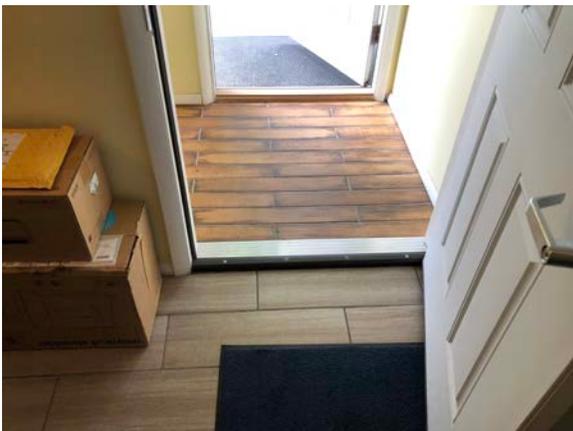
IMAGE 51

- The front entry door is an outswing door with hinges exposed to vandalism. **(IMAGE 51)**
- There is a 4" step up from the sidewalk to the vestibule. **(IMAGE 52)**
- There is a 7-1/2" step down to the garage. **(IMAGE 53)**
- The rear door on the north has a 12' step down to grade. **(IMAGE 54)**
- The tile floor is cracking throughout the main level. In many areas the tile is loose and creating a safety hazard. **(IMAGE 55)**
- The ceiling in the break room and shower are showing signs of failure with cracking and sagging. **(IMAGE 56,57)**
- The wall tile in the shower is showing signs of failure due to water and moisture issues. The tile is bowing off of the wall. **(IMAGE 58)**

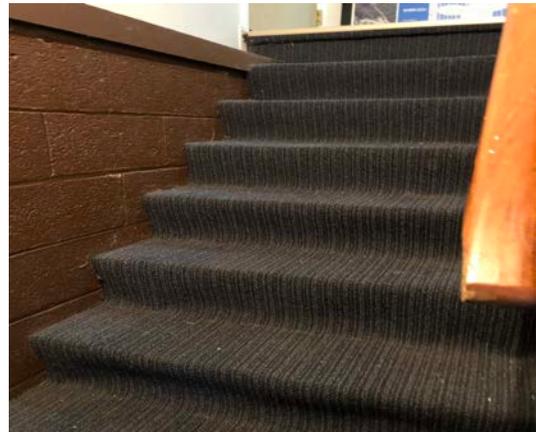
IMAGE 59

- The floors slope from one half inch in four feet to one inch in four feet.
- The floors exhibit significant amounts of “bounce” and deflection.
- The stairway to the basement does not have the proper riser height, tread depth or head clearance as required by code. The handrails also do not meet code. **(IMAGE 59,60)**

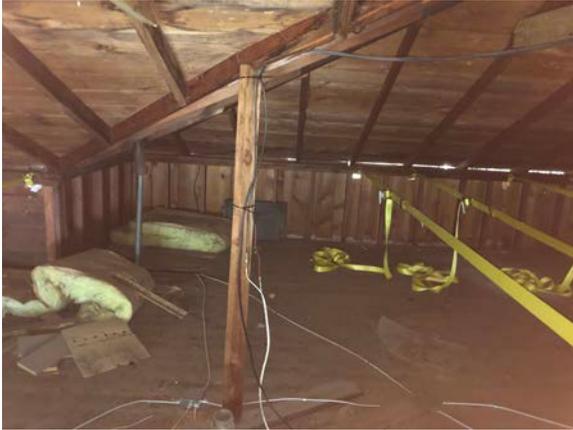
IMAGE 67

- There are many gaps in the exterior siding and framing where daylight is visible through the wall system. **(IMAGE 66,67)**
- The 2 x 4 exterior wall balloon framing is bowing outward at the top of the wall. The amount of outward bow varies from one or two inches to almost five inches at the worst condition. The outward bow is caused by the lateral force of the roof rafters. **(IMAGE 68)**

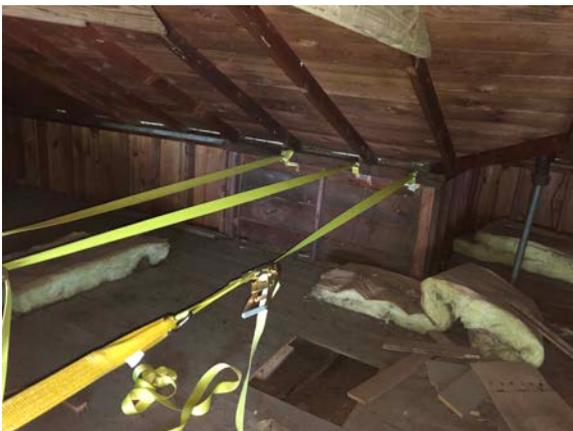
IMAGE 69

- The 2 x 4 rafters are severely over-spanned for the rafter spacing, rafter size and span. The rafters exhibit sagging due to the over-span condition. **(IMAGE 69)**

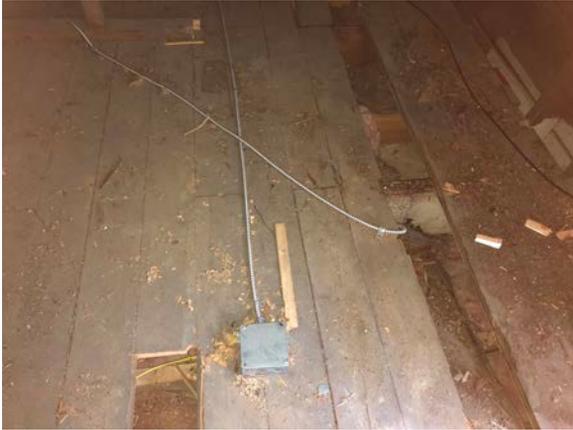
IMAGE 79

- Some of the flexible conduit (MC Cable) is also loosely run in the attic and basement areas. **(IMAGE 79,80)**
- The electrical fixtures located in the shower are not proper for the location and present an electrical hazard to persons using the shower. **(IMAGE 81)**

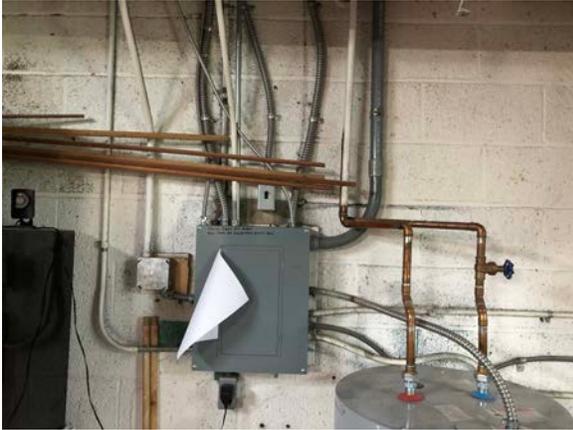
IMAGE 91

- The electric panel is adequate however the work is sloppy. **(IMAGE 91)**

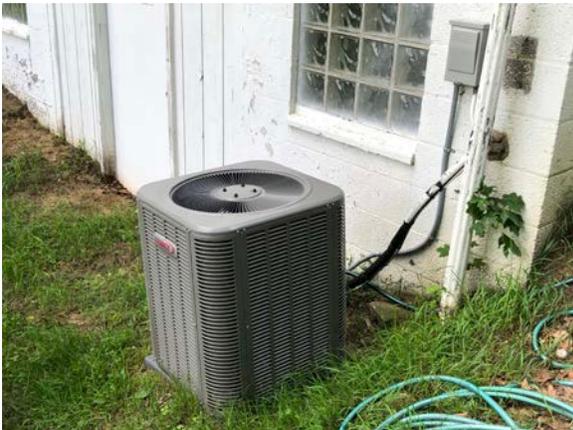
IMAGE 92

- The furnace and air conditioner are newer units and appear to be in good working order. **(IMAGE 92,93)**
- The adequacy of the heating & cooling system was not analyzed.
- Ductwork in the crawlspace is not insulated. **(IMAGE 94)**
- The exhaust fan in the shower is dangerously mounted in the wall low enough to have water enter and create an electrical hazard to shower users. **(IMAGE 95)**

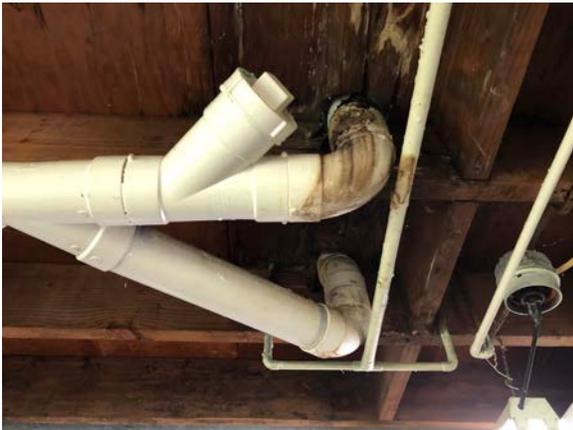
IMAGE 98

- The well tank is newer with an installation date of 2018. No issues are known. **(IMAGE 96)**
- The water heater is also newer with an installation date of 2017. No issues are known. **(IMAGE 97)**
- The drain piping for the shower shows signs of leakage, possibly from a failure of the shower membrane. **(IMAGE 98)**
- Plumbing fixtures and installations do not comply with the accessibility code. **(IMAGE 99,100)**
